## Hotel Roof Waterproofing

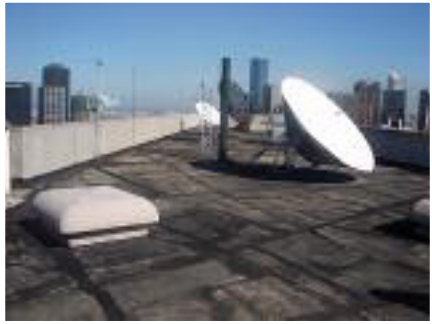
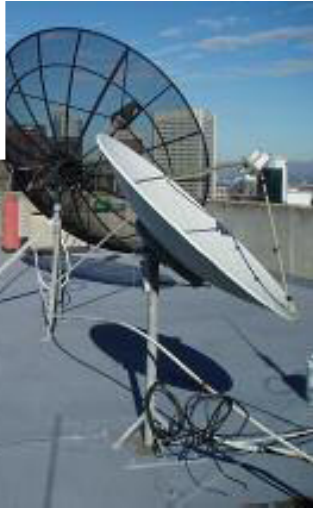
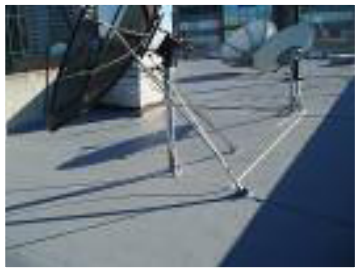
Old bitumen based surface had blistered and broken down over time, resulting in water leaks through the ceiling to the plant room below. This condition has been accelerated by tradesmen leaving their mark on the surface as additional technology services have been installed.

Waterproof the entire surface with a waterproofing membrane, embedded with fibreglass matting. Special care taken to cover the joints to parapet wall and services equipment.
