Hotel Roof Waterproofing

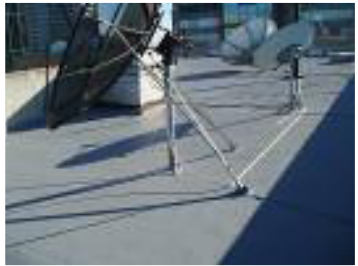
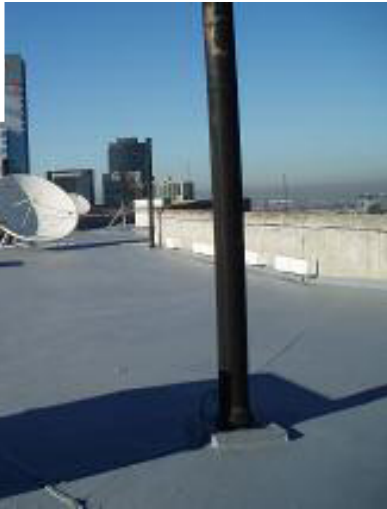
Old bitumen based surface had blistered and broken down over time, resulting in water leaks through the ceiling to the plant room below. This condition has been accelerated by tradesmen leaving their mark on the surface as additional technology services have been installed.

Waterproof the entire surface with a waterproofing membrane, embedded with fibreglass matting. Special care taken to cover the joints to parapet wall and services equipment.

Microl 200 waterproofing membrane, Sikaflex PRO, fibreglass matting
