School Balcony Waterproof Repair

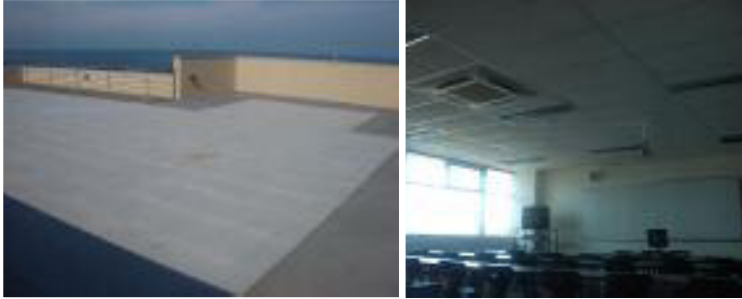
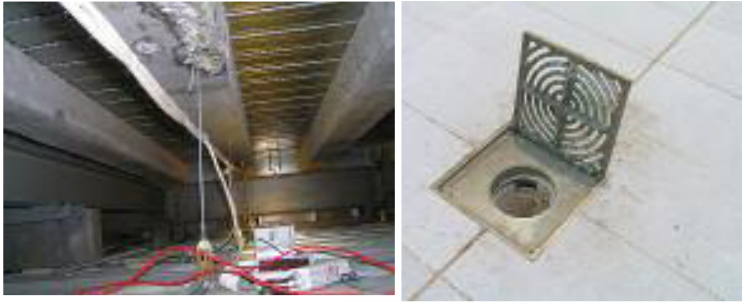
New building had waterproofing membrane ruptured during railing and tiling process, resulting in water finding the weak point in the slab. Result, water dripping through ceiling to class room below.

Temporary solution was to isolate the obvious damage points around the drains and railing. Lifting tiling, re-waterproofing and correctly fitting drains. Then adding screed and tiles back.
