## Repair and Seal Garage Floor

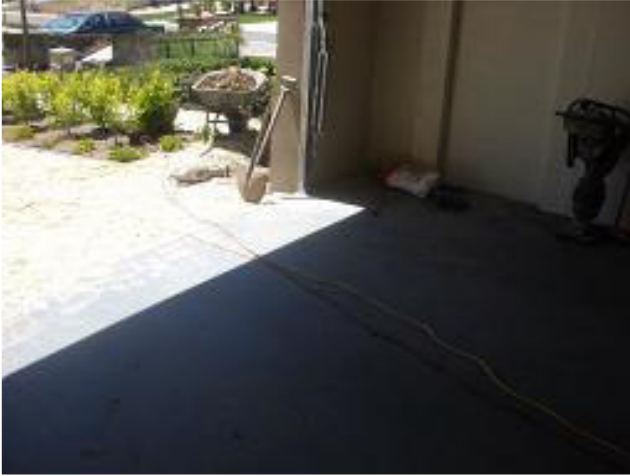
Residential garage in new housing estate suffered from excessive dust, undulation and poor visual appearance. The garage entrance formed the security to the front door, adding importance to the area. As the concrete condition was 'caulky' with levelling problems which didn't allow the garage doors to be closed, the problem needed to be fixed.

The job required a full concrete grind of the floor, patch and repair damaged zones as the first step of preparation. The finishing treatment was multiple coats of water based , two part, coloured epoxy coating
