Restoration of Balcony and cornice decoration

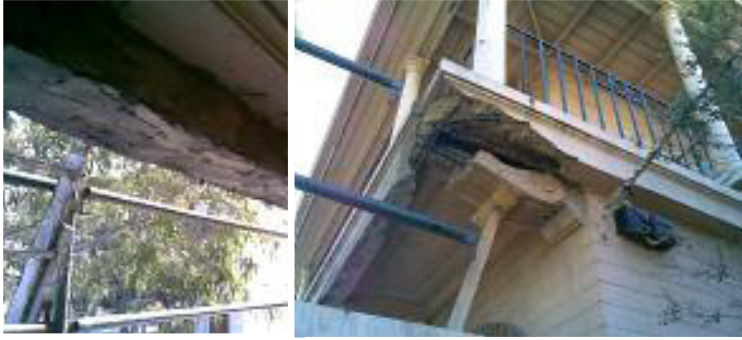
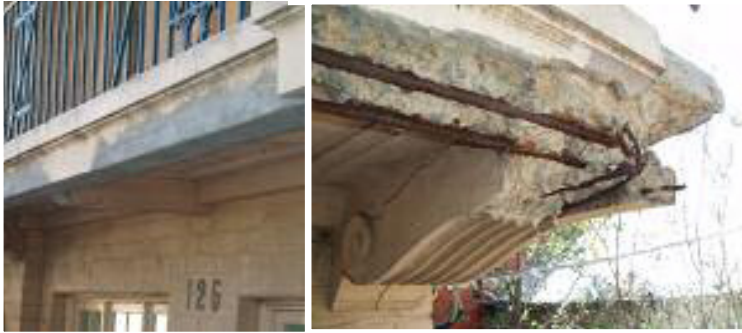
Balcony was suffering from rusting reo, exploding the concrete from the edge of the concrete slab. Damage to the cornices and front detracted from the appearance of the premises.

Chase out 'drummy' concrete around the exposed 'reo', treat metal with rust inhibitor and metal primer.. Build back the lintel and cornices to match the original profile, then paint to finished look.
