SECTION 11 BALCONY DESIGN CONSIDERATIONS

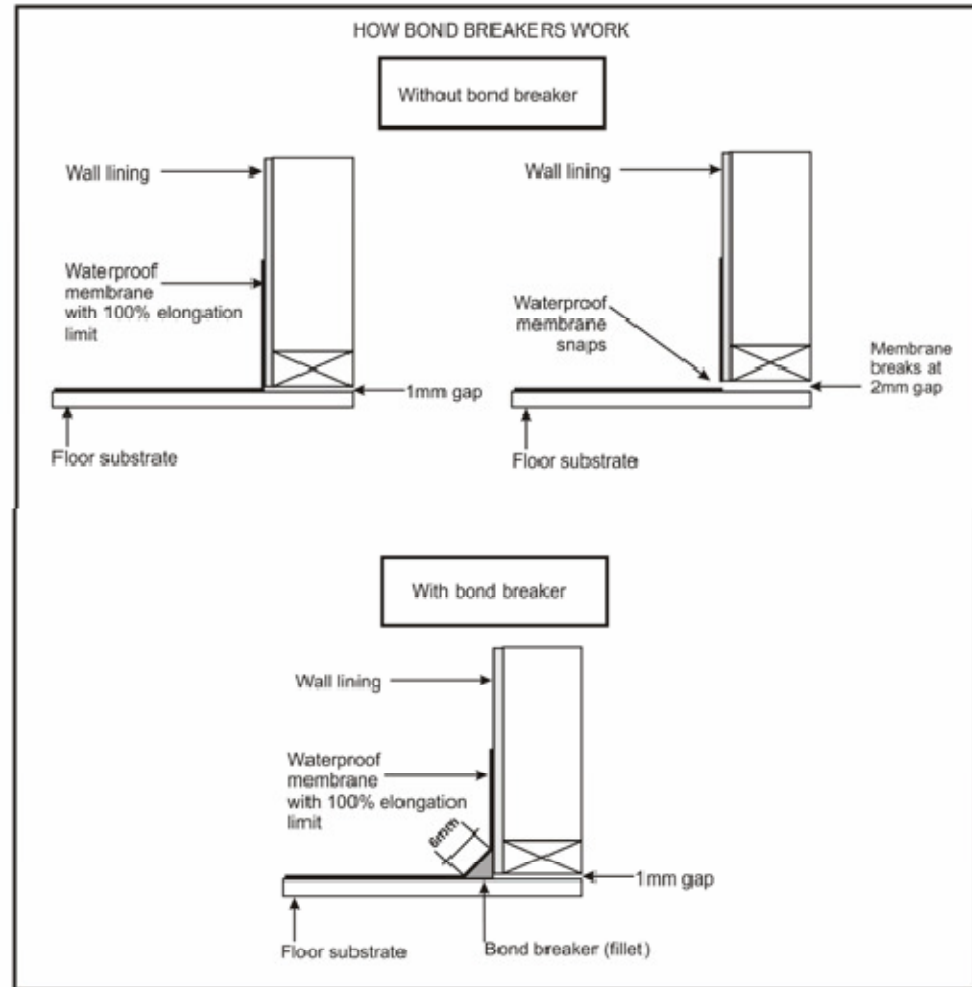
## HOW BOND BREAKERS WORK

*Note: Lack of an effective bond breaker is the most common single source of a waterproofing system breakdown.*

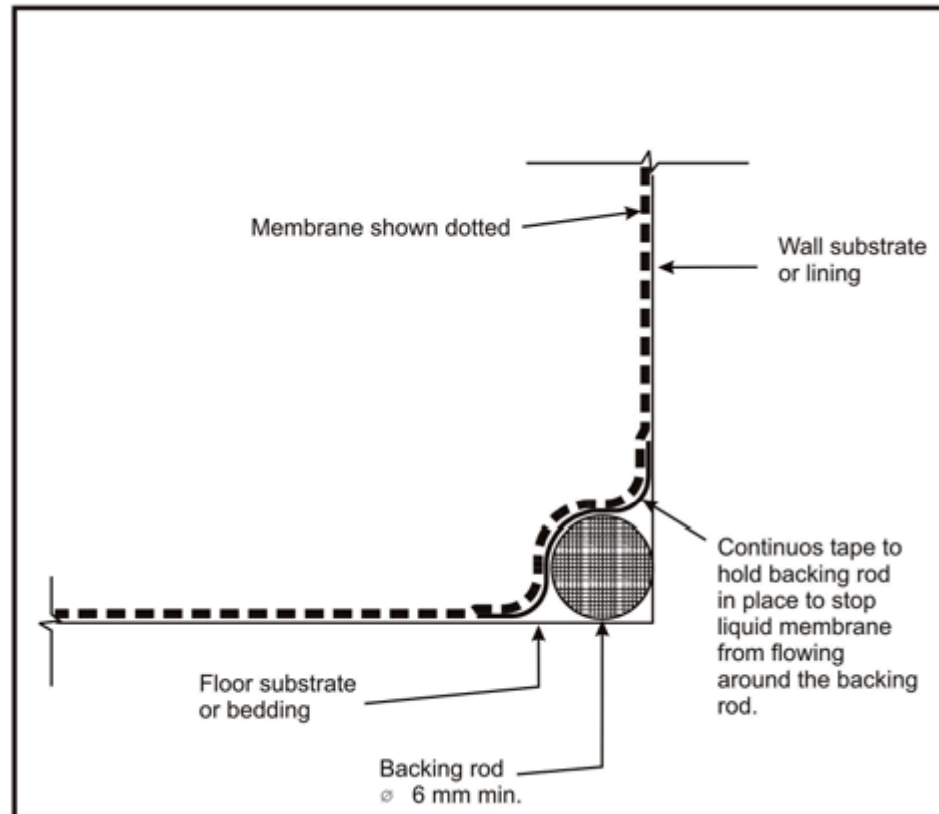
TYPICAL BOND BREAKER DETAIL FOR CLASS I MEMBRANES AT A WALL / FLOOR JUNCTION

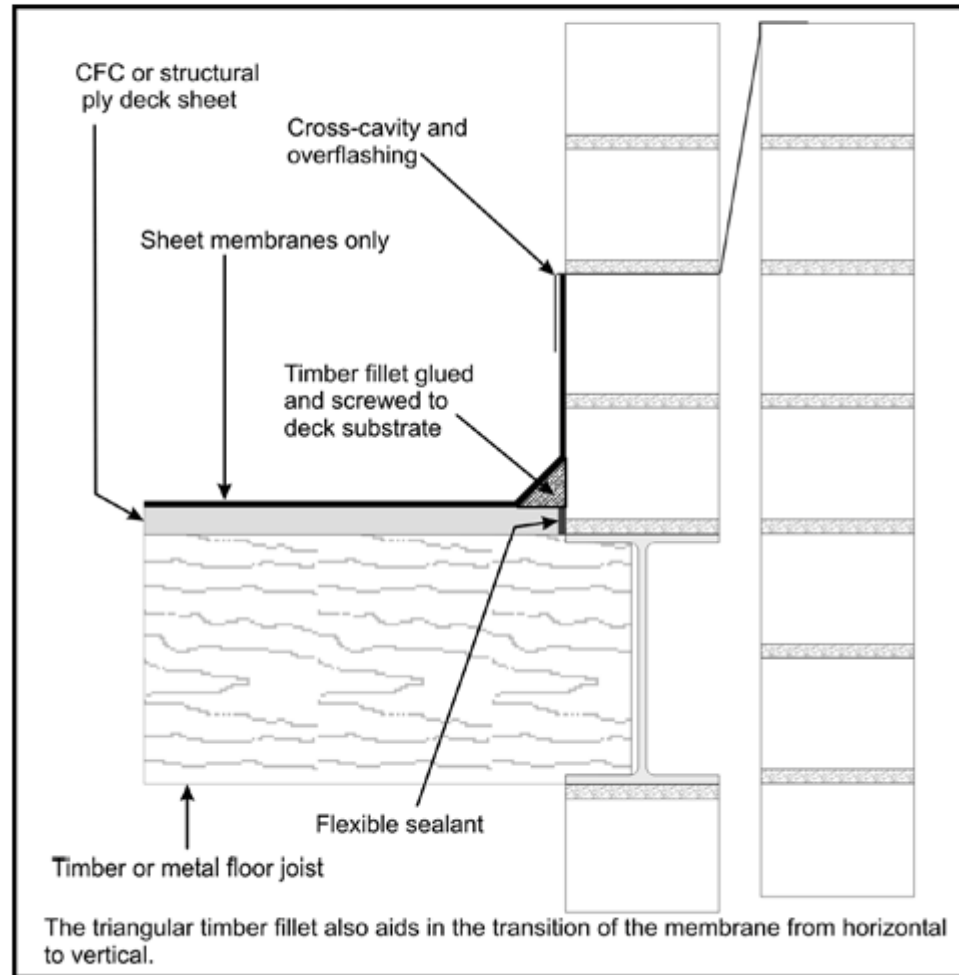
TIMBER FILLET DETAIL FOR CLASS I SHEET MEMBRANES

*\* Do not use this detail for resin based or liquid applied systems.*

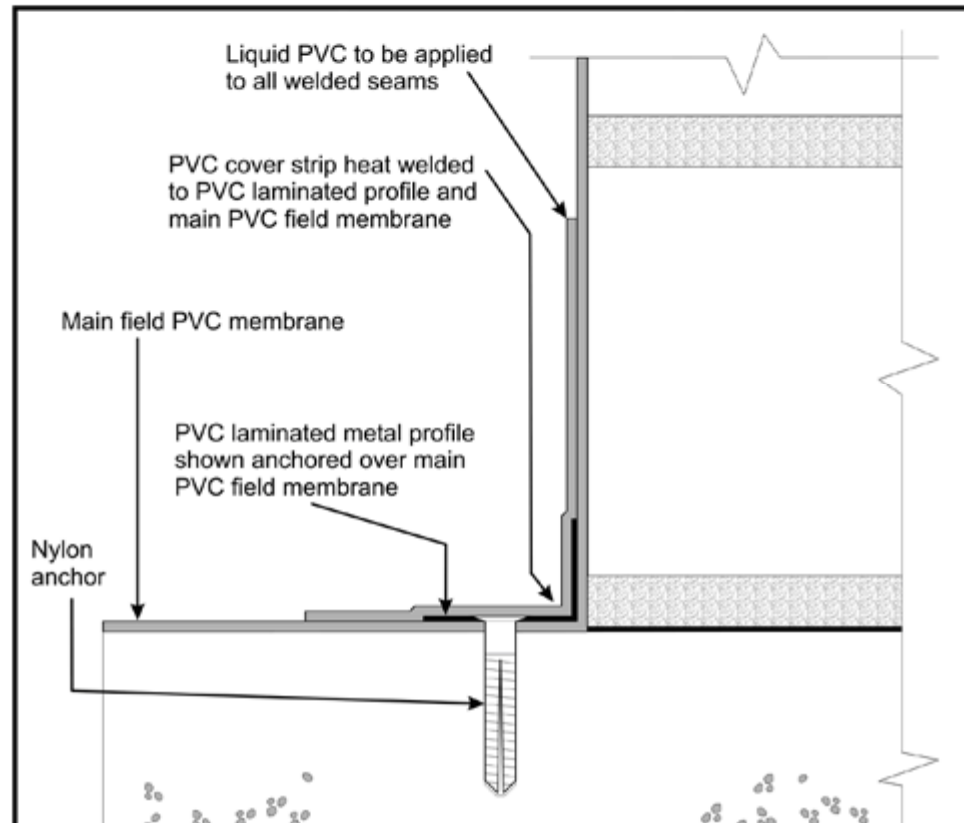
TYPICAL FILLET DETAIL FOR CLASS III PVC MEMBRANES

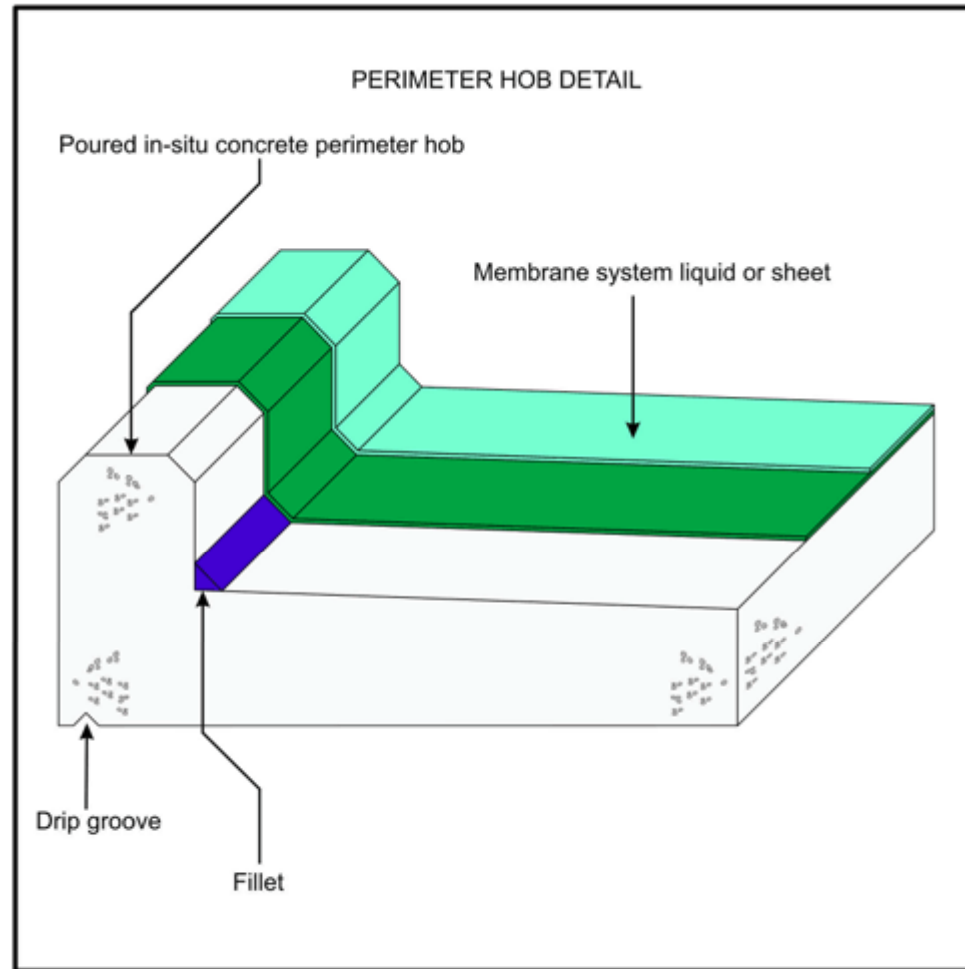
PERIMETER HOB DETAIL

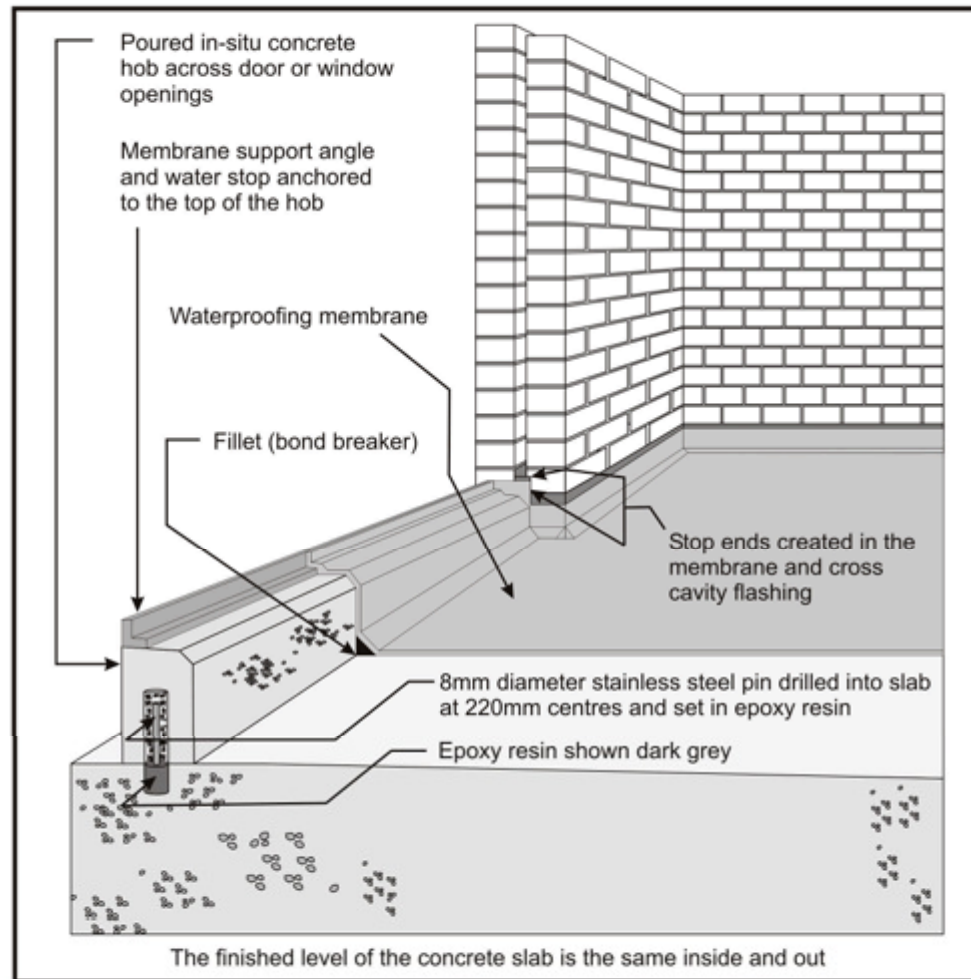
HOBBS THAT ARE POURED AS A SECONDARY UNIT

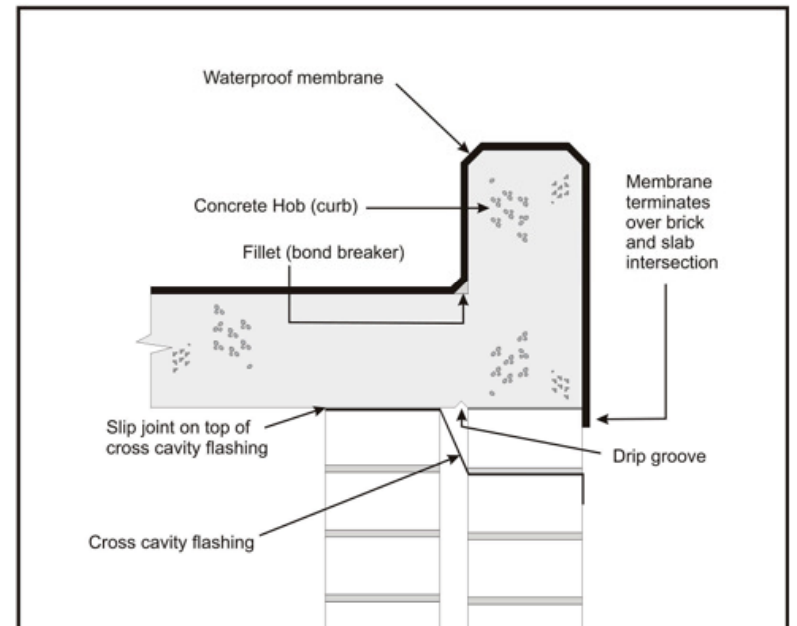
HOB TERMINATION DETAIL IN CONCRETE

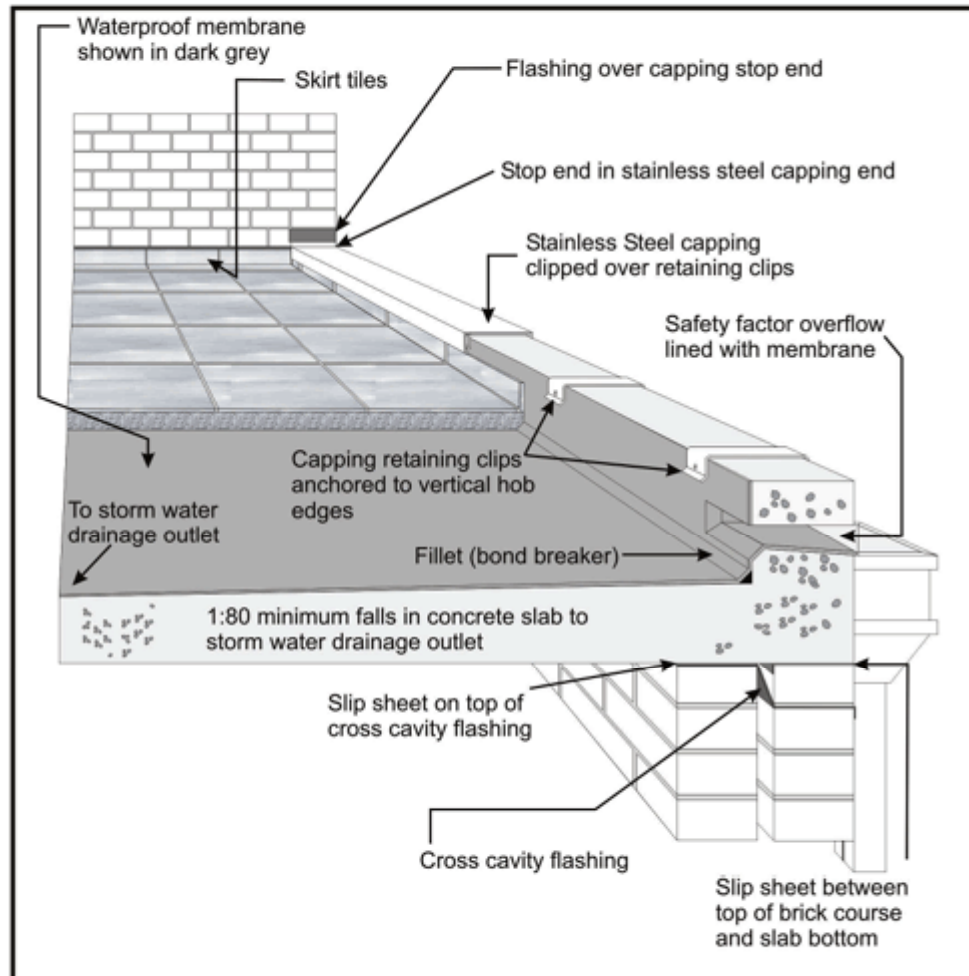
HOB DETAIL WITH METAL CAPPING

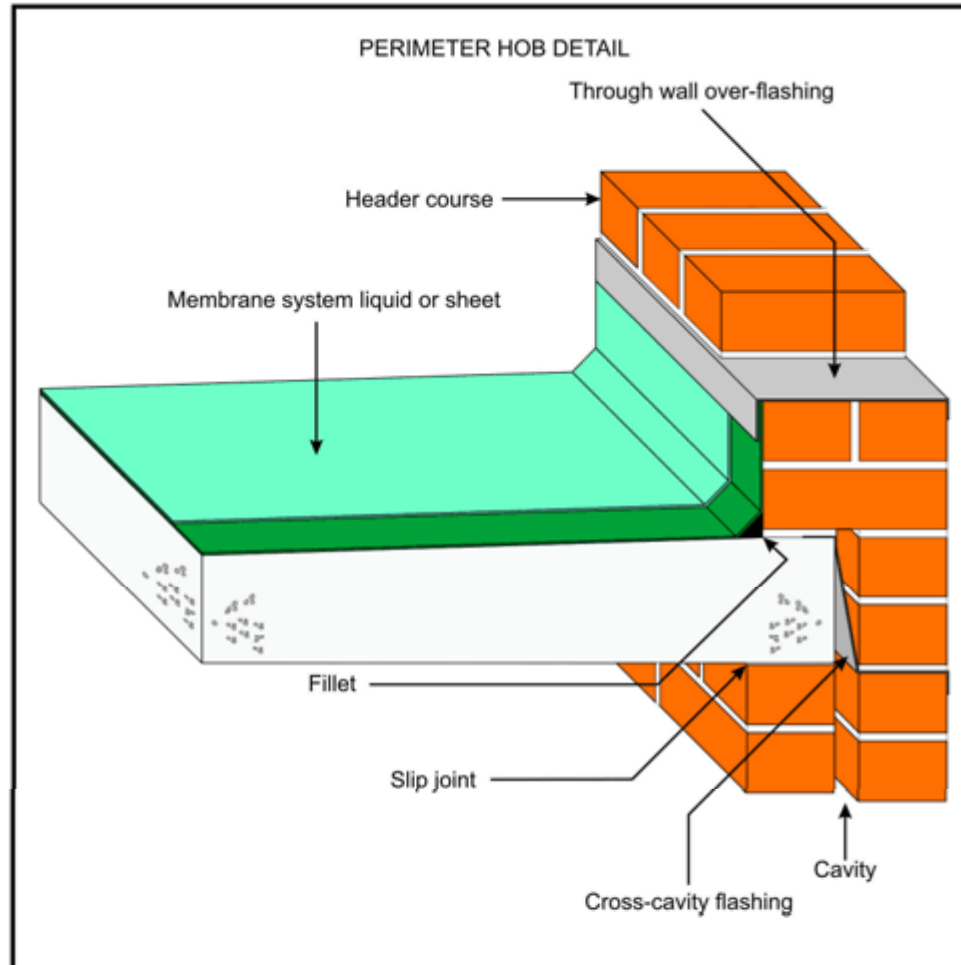
PERIMETER HOB DETAIL

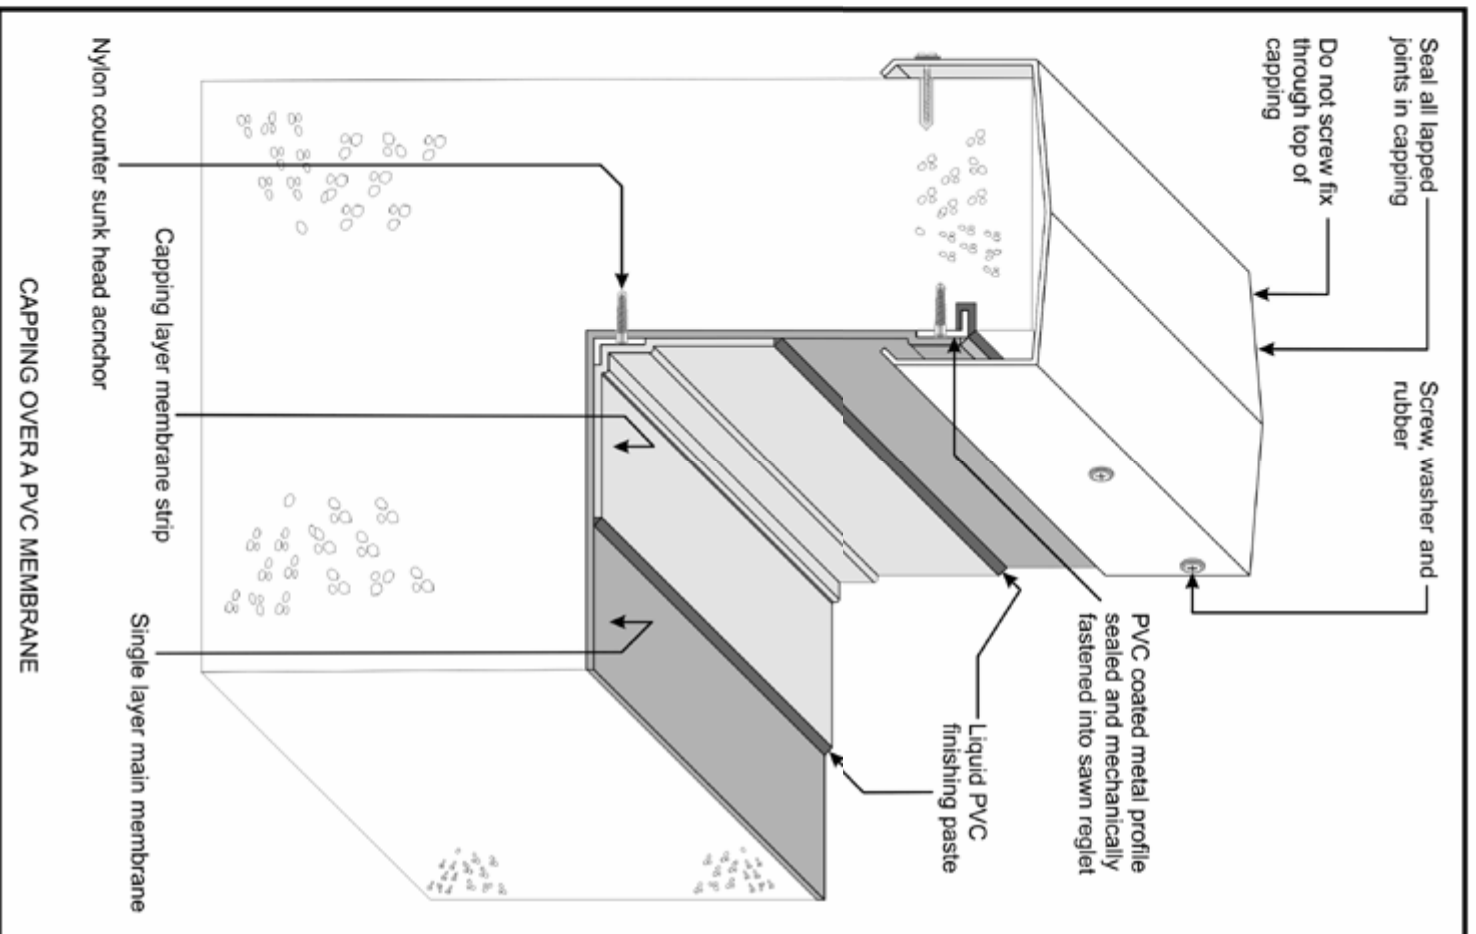
## CAPPING

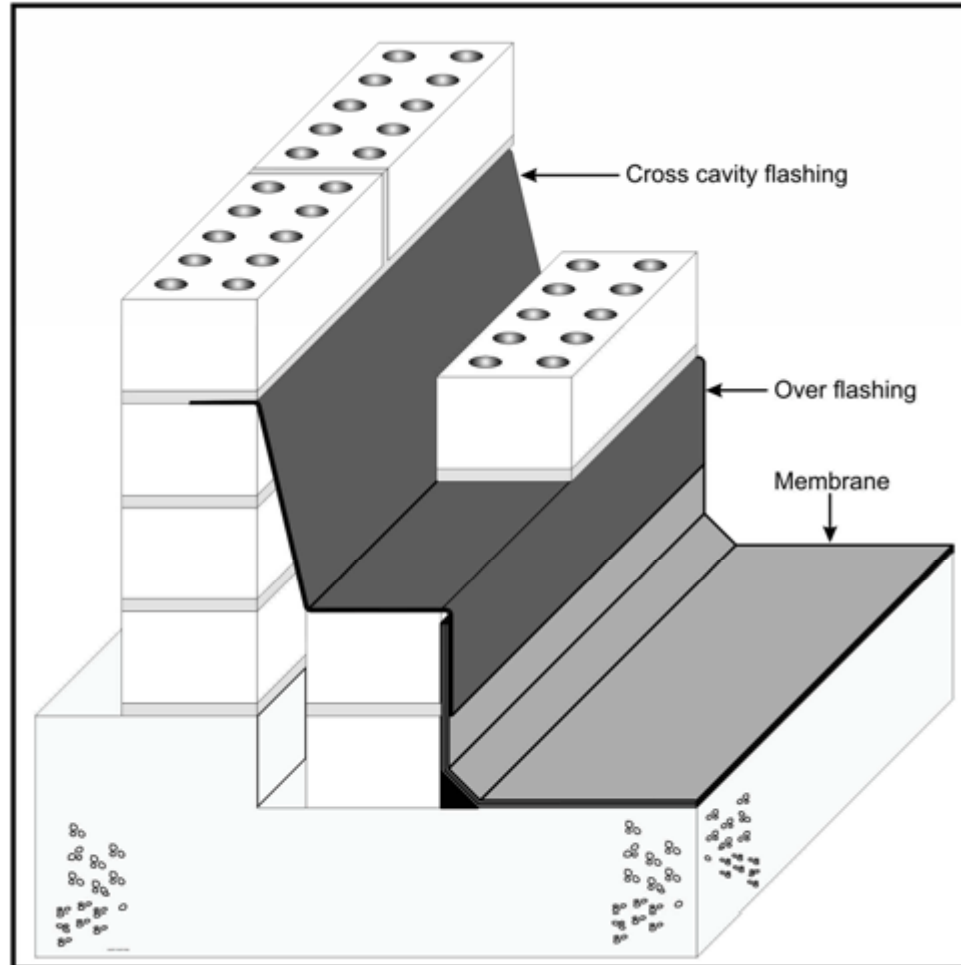
OVERFLASHING

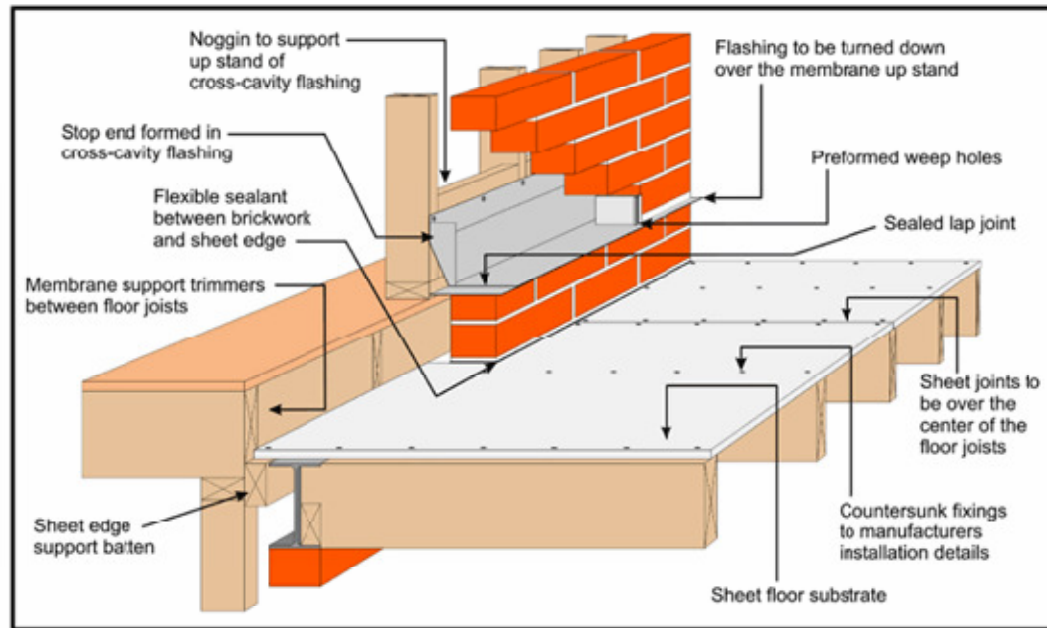
OVERFLASHING

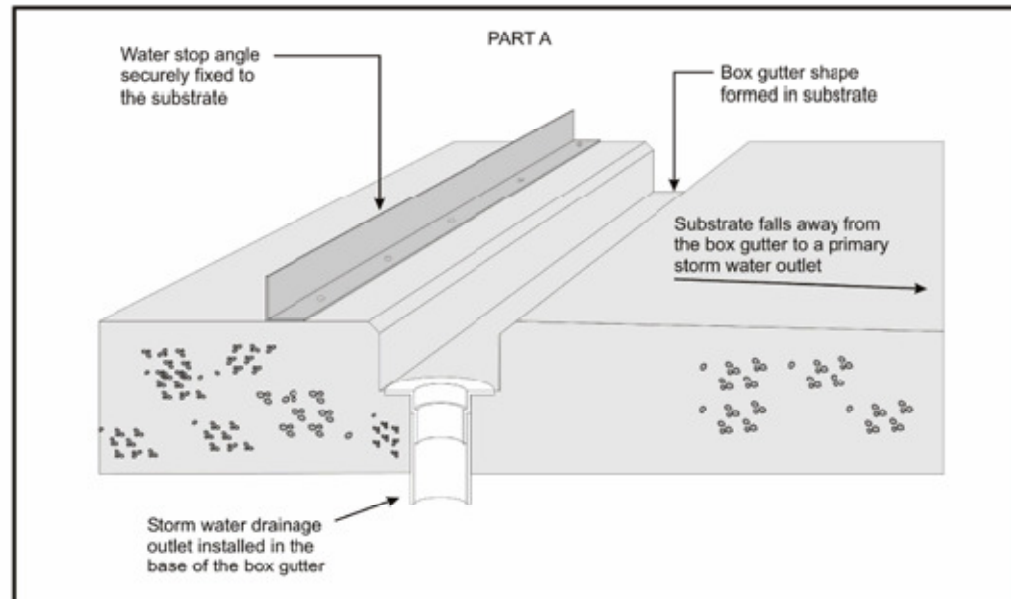
## DRAINAGE OUTLETS

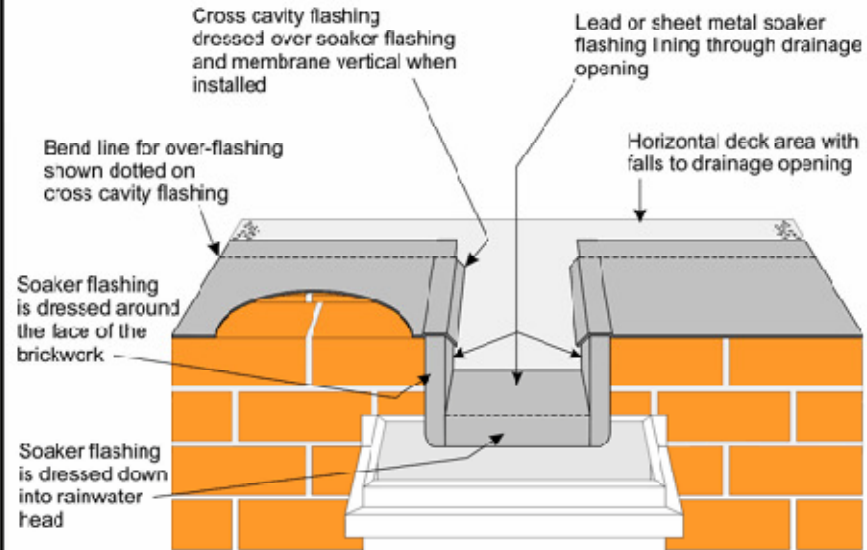
FLASHING AND MEMBRANE SUPPORT PREPARATION  
OF A THROUGH WALL DRAINAGE OUTLET

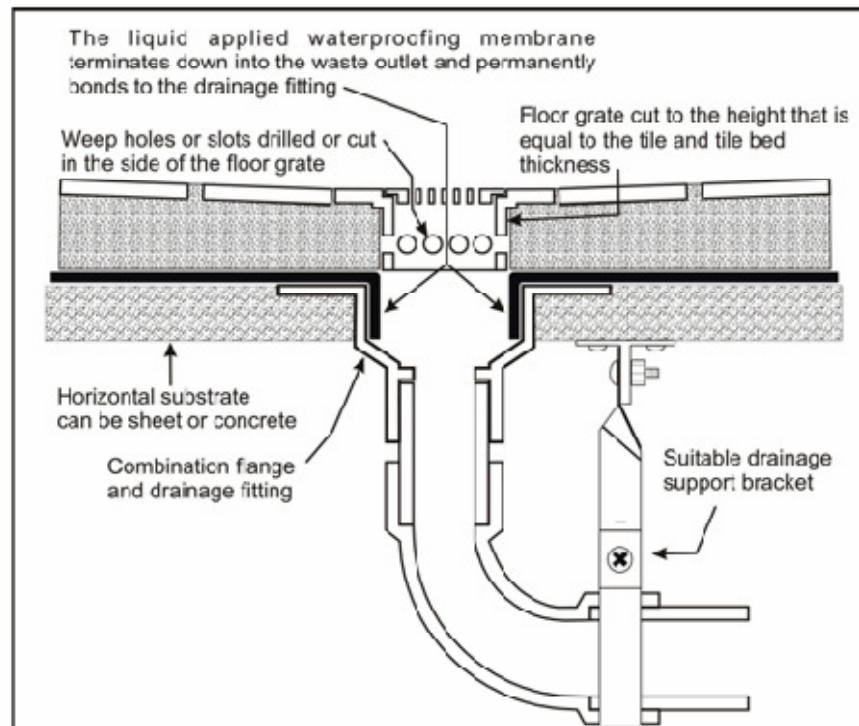
DRAINAGE OUTLETS

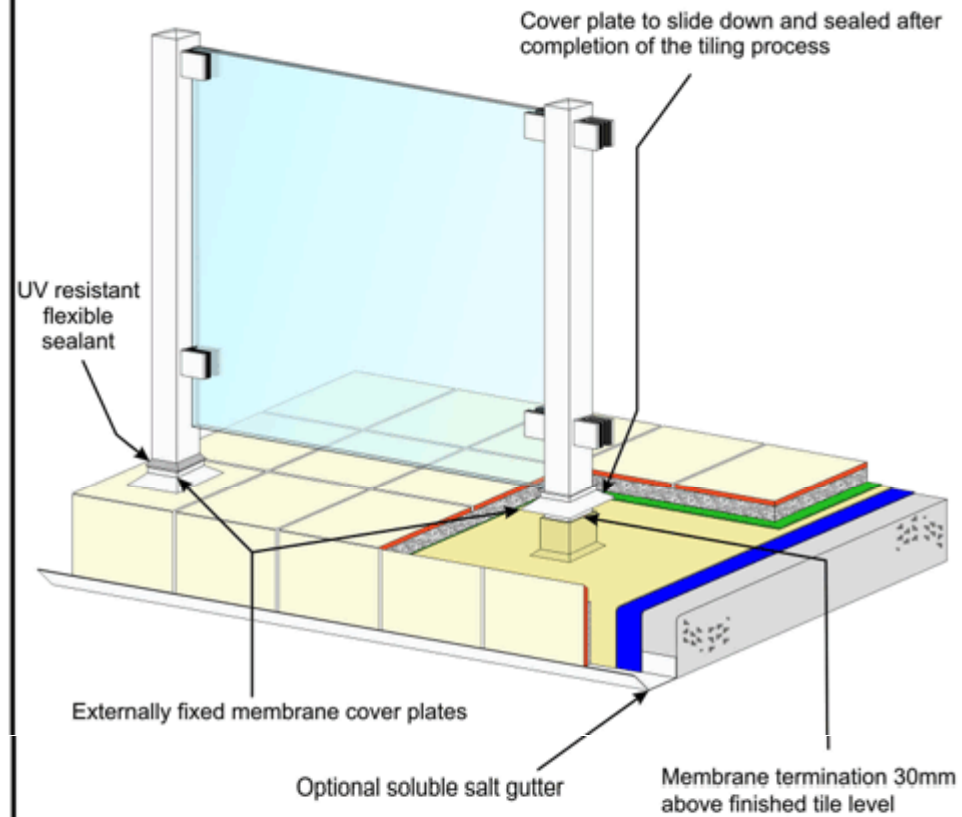
BALUSTRADE POSTS FIXED ONTO CONCRETE SLAB

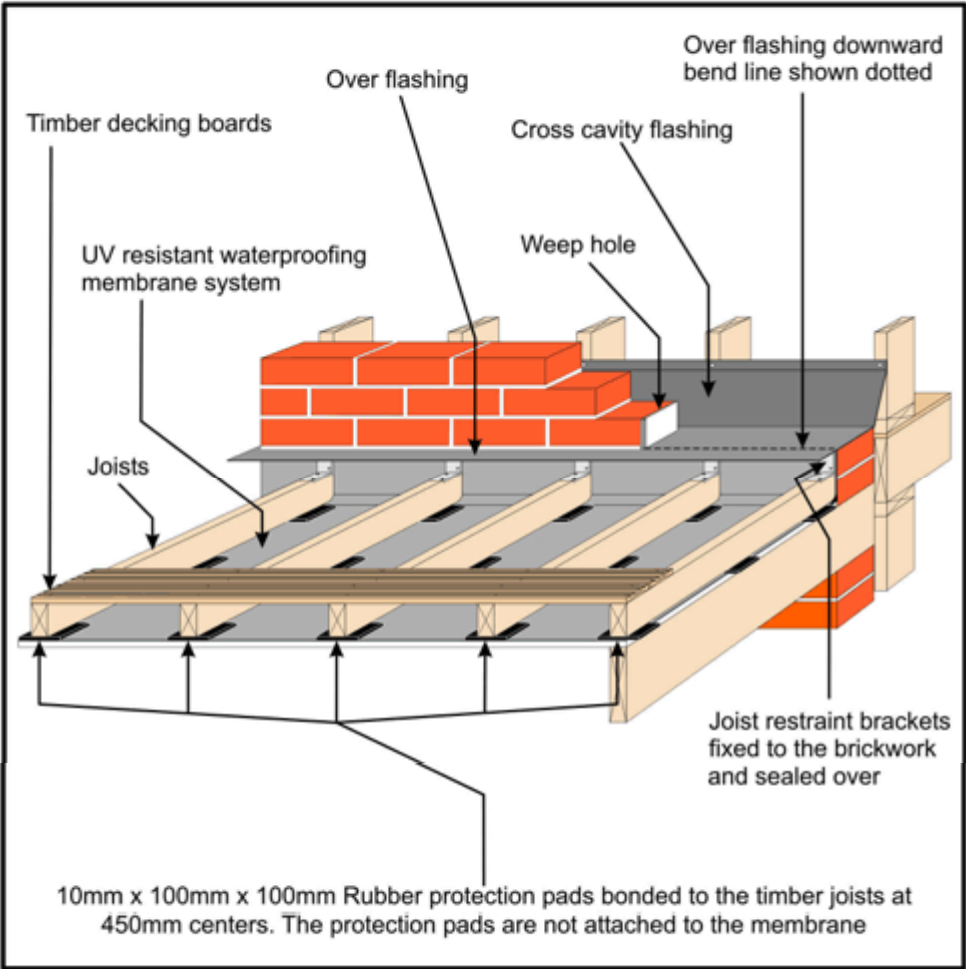
CROSS CAVITY FLASHINGS AND TIMBER DECKS
