Bathroom Renovation

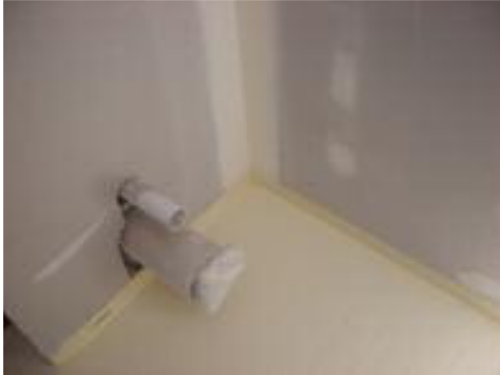
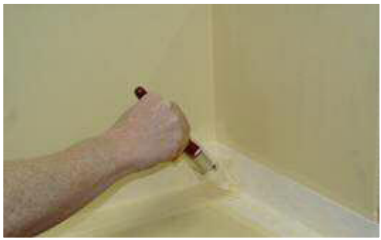
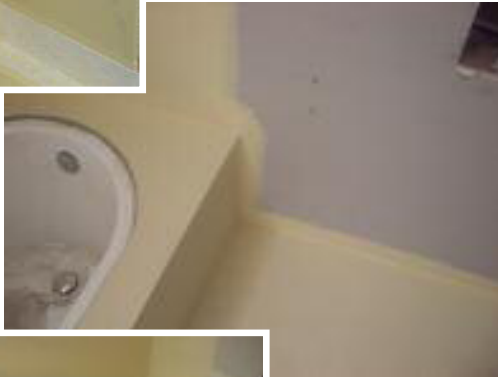
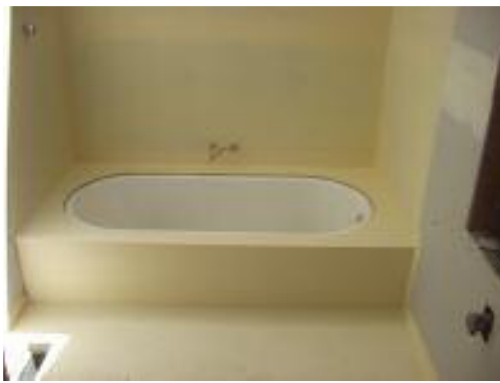
Architect had designed a unique bath/shower configuration in a bathroom renovation. This configuration exposed the possibility of additional water spreading to other parts of the bathroom.

Cover a larger area with waterproofing membrane than the standard requires. Taking special care to cork and cloth the joints around the bath, wall joints and doorway.

Fibreflex waterproofing membrane, Sikaflex PRO, polycloth
