Restoring damaged Lintels

'HOW TO' INSTRUCTIONS

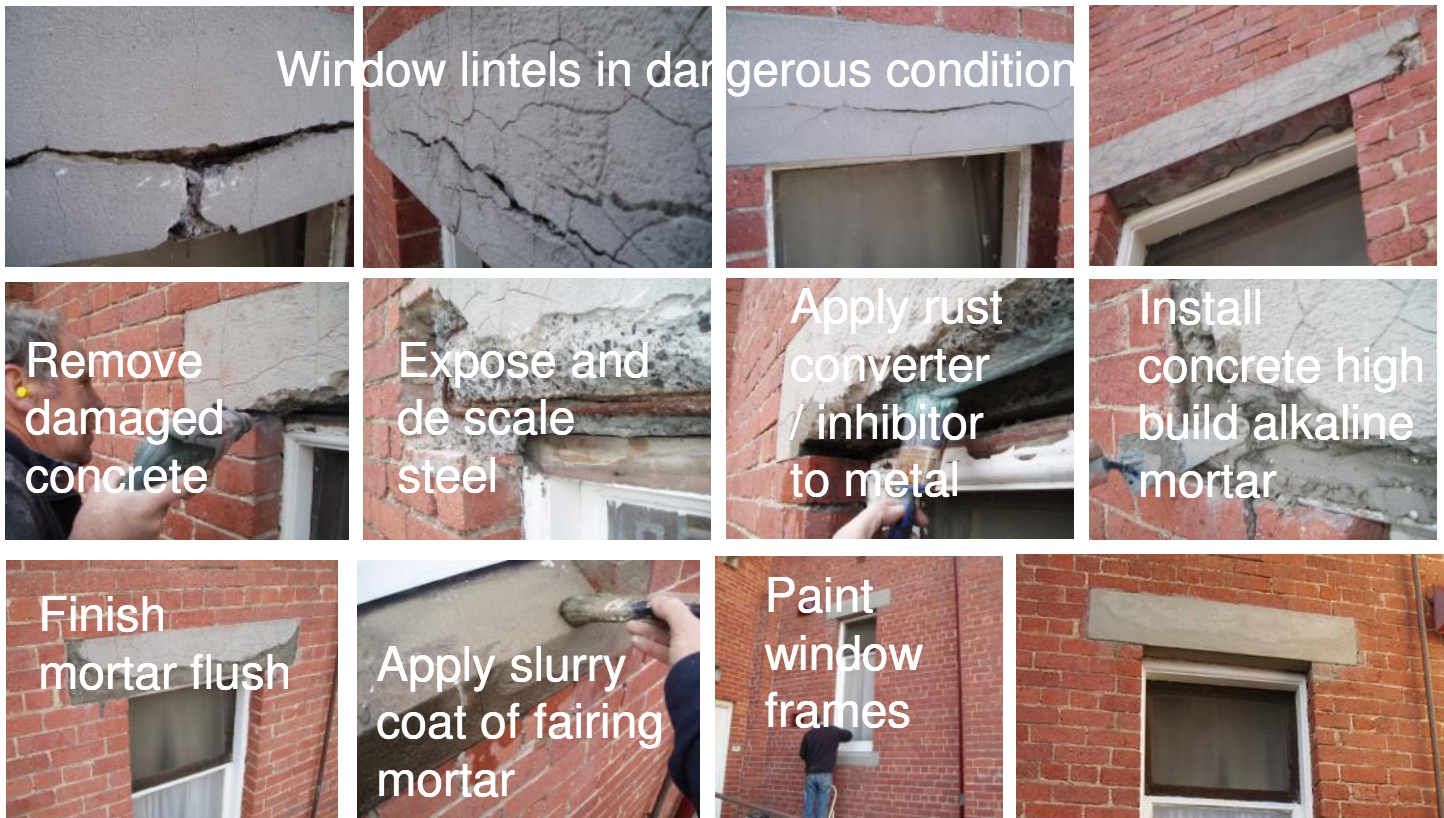
When steel reinforcing rusts it expands and explodes the concrete. This can result in a dangerous situation, as concrete may dislodge falling to the ground. The following is a practical suggestion to remedy the problem.

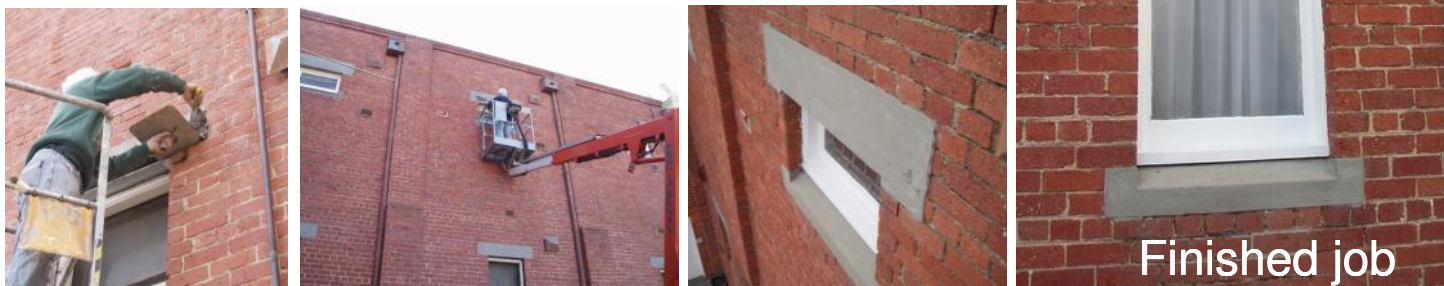
Working at heights with appropriate safety equipment.
