Restoring Exploding Lintels

Restoring damaged Lintels

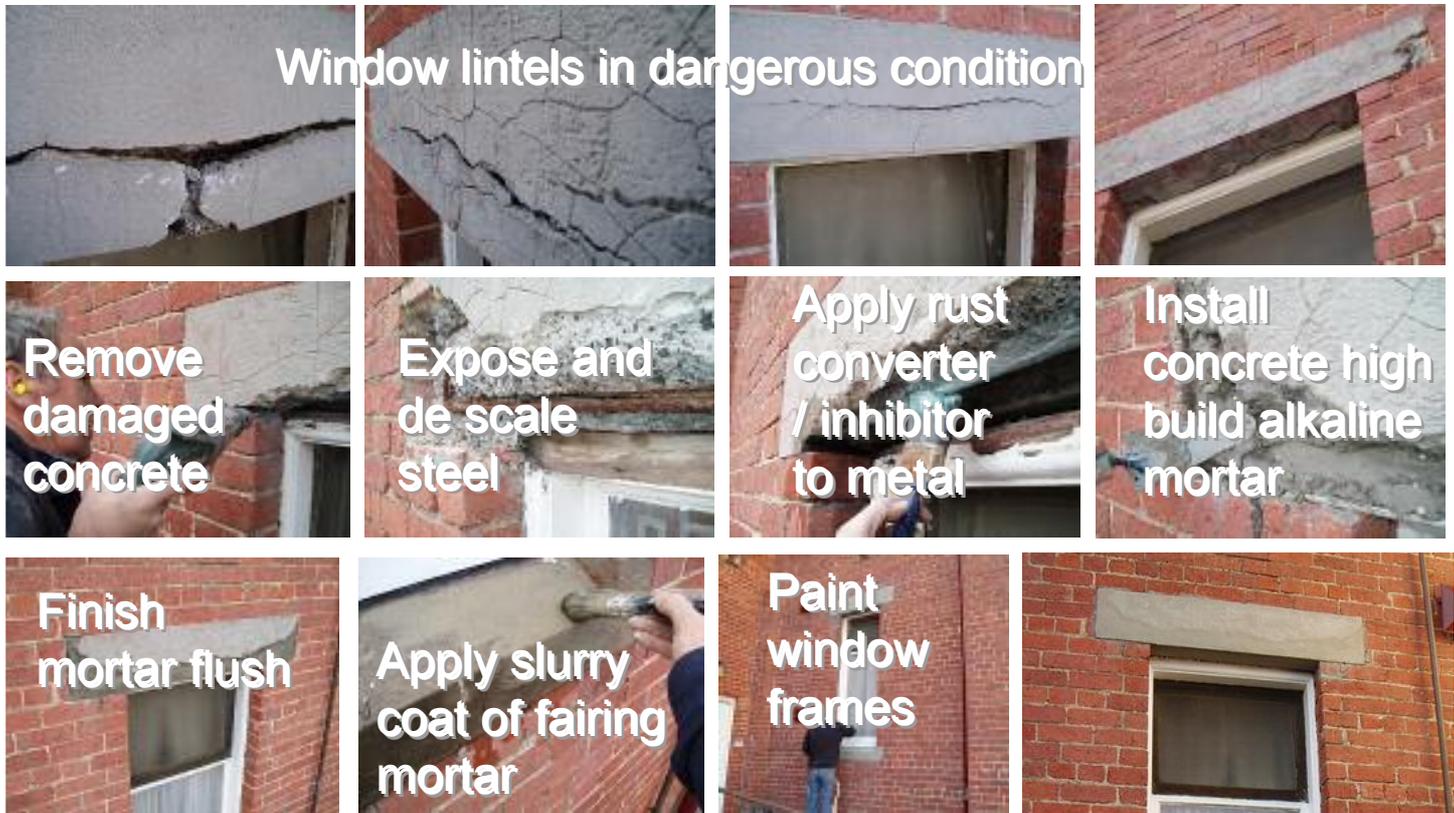
When steel reinforcing rusts it expands and explodes the concrete. This can result in a dangerous situation, as concrete may dislodge falling to the ground. The following is a practical suggestion to remedy the problem.

Use mechanical and hand chisel methods to dig deep into the concrete lintel to remove all concrete from the area around the rusting metal. Often it requires cutting into the concrete more than anticipated.

Start with cleaning and mechanically abrade the steel surface, then apply a rust inhibitor. If additional steel reinforcing required, secure with Sikadur 31. Apply the high build mortar in accordance with specifications, flush to the level of the existing surface.

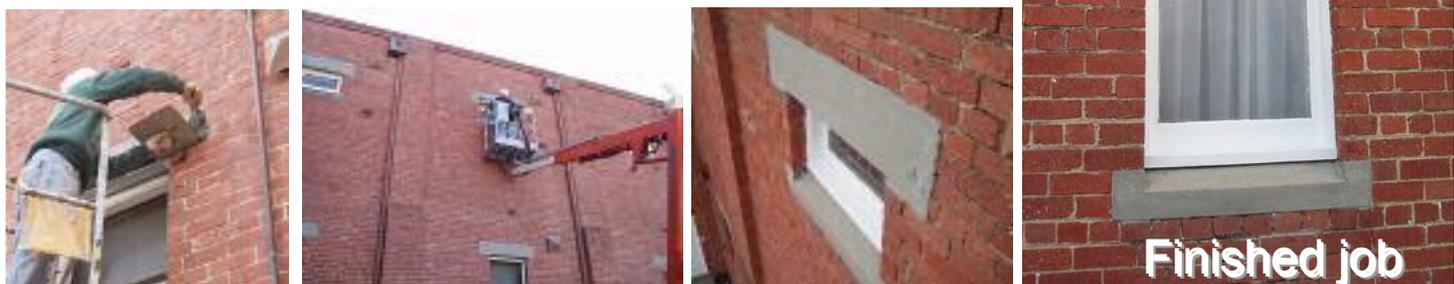
Working at heights with appropriate safety equipment.
