LINTELS

Restoring Exploding Lintels

'HOW TO' INSTRUCTIONS

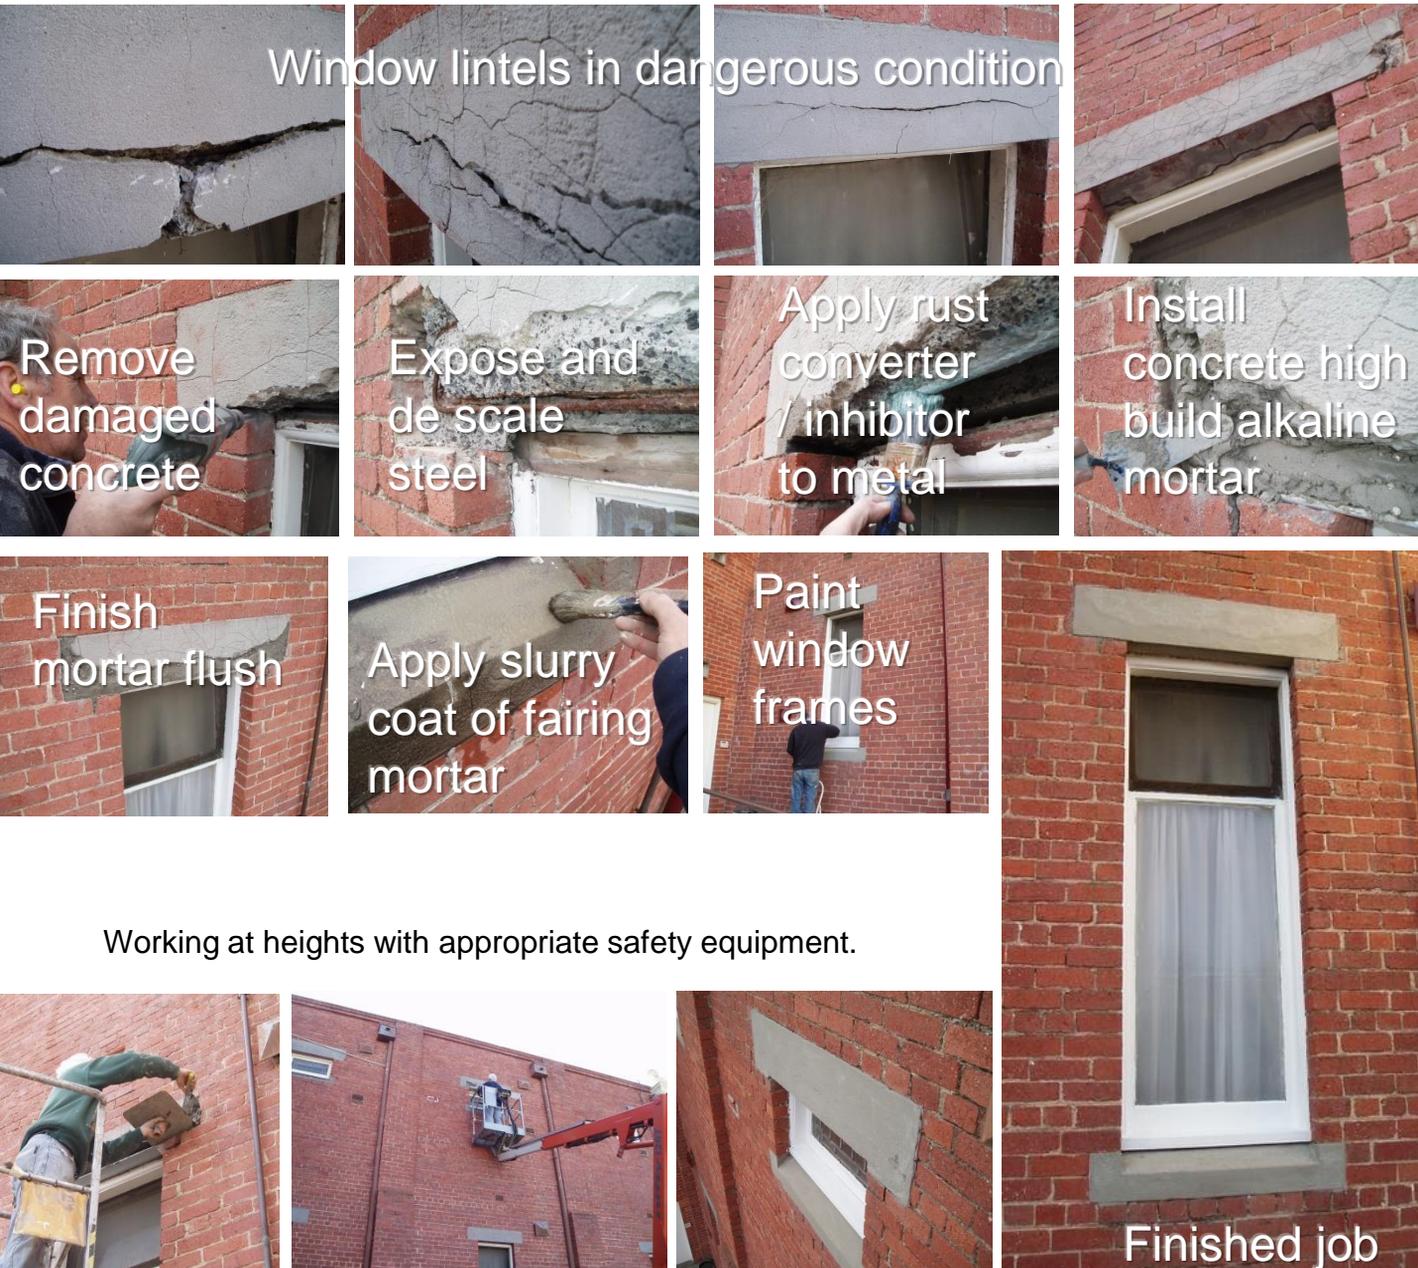
When steel reinforcing rusts it expands and explodes the concrete. This can result in a dangerous situation, as concrete may dislodge falling to the ground. The following is a practical suggestion to remedy the problem.

Thoroughly remove all damaged parts of the lintel:

Use mechanical and hand chisel methods to dig deep into the concrete lintel to remove all concrete from the area around the rusting metal. Often it requires cutting into the concrete more than anticipated.

Start with cleaning and mechanically abrade the steel surface, then apply a rust inhibitor. If additional steel reinforcing required, secure with Sikadur 31. Apply the high build mortar in accordance with specifications, flush to the level of the existing surface.
